Contract #: 04-0120F4Cty: SF/ALA Rte: 80 PM: 13.2/13.9File #: 69.28**WELDING INSPECTION REPORT****Resident Engineer:**Siegenthaler, Peter**Address:** 333 Burma Road**City:** Oakland, CA 94607**Report No:** WIR-018540**Date Inspected:** 07-Dec-2010**Project Name:** SAS Superstructure**OSM Arrival Time:** 700**Prime Contractor:** American Bridge/Fluor Enterprises, a JV**OSM Departure Time:** 1900**Contractor:** Zhenhua Port Machinery Company, Ltd (ZPMC), Changxing Island **Location:** Shanghai, China**CWI Name:** Mr. Wang li yang**CWI Present:** Yes No**Inspected CWI report:** Yes No N/A**Rod Oven in Use:** Yes No N/A**Electrode to specification:** Yes No N/A**Weld Procedures Followed:** Yes No N/A**Qualified Welders:** Yes No N/A**Verified Joint Fit-up:** Yes No N/A**Approved Drawings:** Yes No N/A**Approved WPS:** Yes No N/A**Delayed / Cancelled:** Yes No N/A**Bridge No:** 34-0006**Component:** Orthotropic Box Girder(OBG)**Summary of Items Observed:**

WELDING INSPECTION REPORT

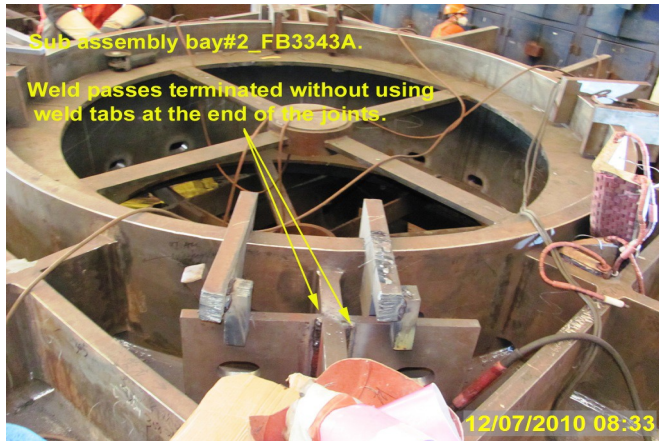
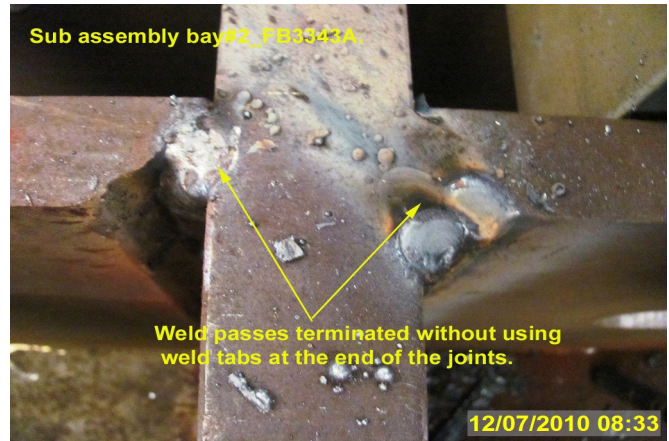
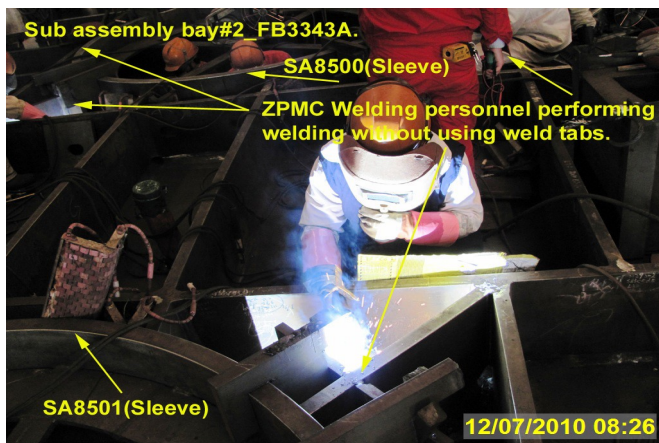
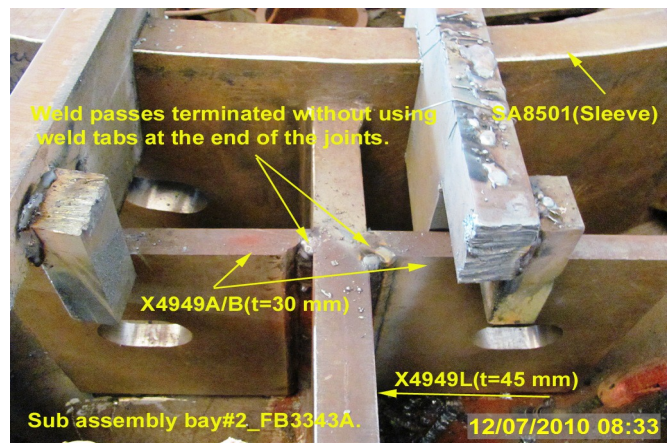
During QA random in-process observations of the fabrication of OBG Lift 14 West Floor beam hinge plate (FB) FB3343A, this Caltrans QA Inspector observed ZPMC Welding personnel performing welding without using weld tabs (extension bars and run off plates).The use of weld tabs is specified in AWS D1.5 2002 section 3.12.1.The weld joints are identified as FB3343-001-081,085,067,071,143,147,129 and 133.The welds are Partial Joint Penetration, T joints joining stiffener (X4949A/B) to stiffener (X4949L).The welding was being performed using Flux cored arc welding process in vertical (3G) position. The thickness of the stiffener plates is 45 mm and 30 mm.

This QA Inspector generated an incident report for the above issue on this date, for further information see the incident report and attached photos.
